# Bad Actor Elimination in Pumps

Vasanth Bhat and Thangavel Suthan  
Singapore Refining Company

# Case 1 : Slurry Bottoms Pump

# Case Study 2: Lean MEA Pump

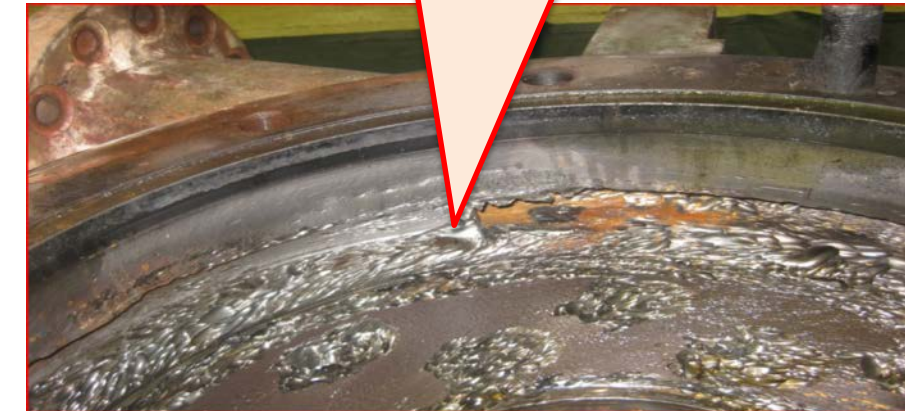
Erosion at volute casing tongue

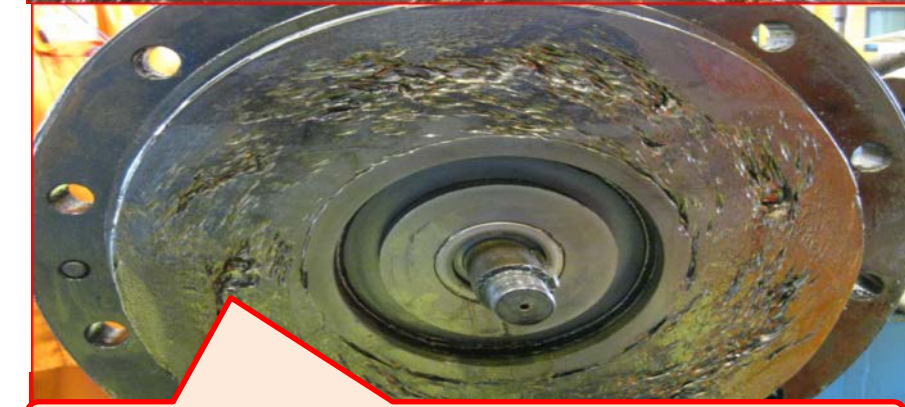
Erosion at pump head patch plate

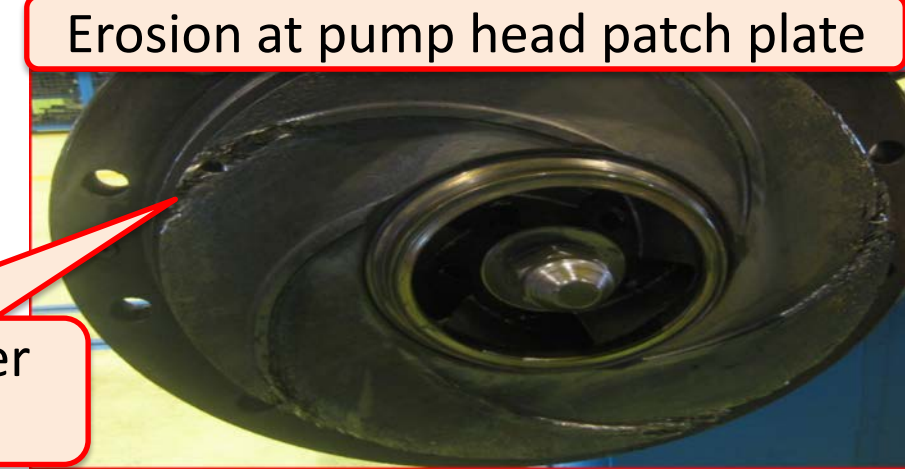
Erosion at impeller pump out vanes

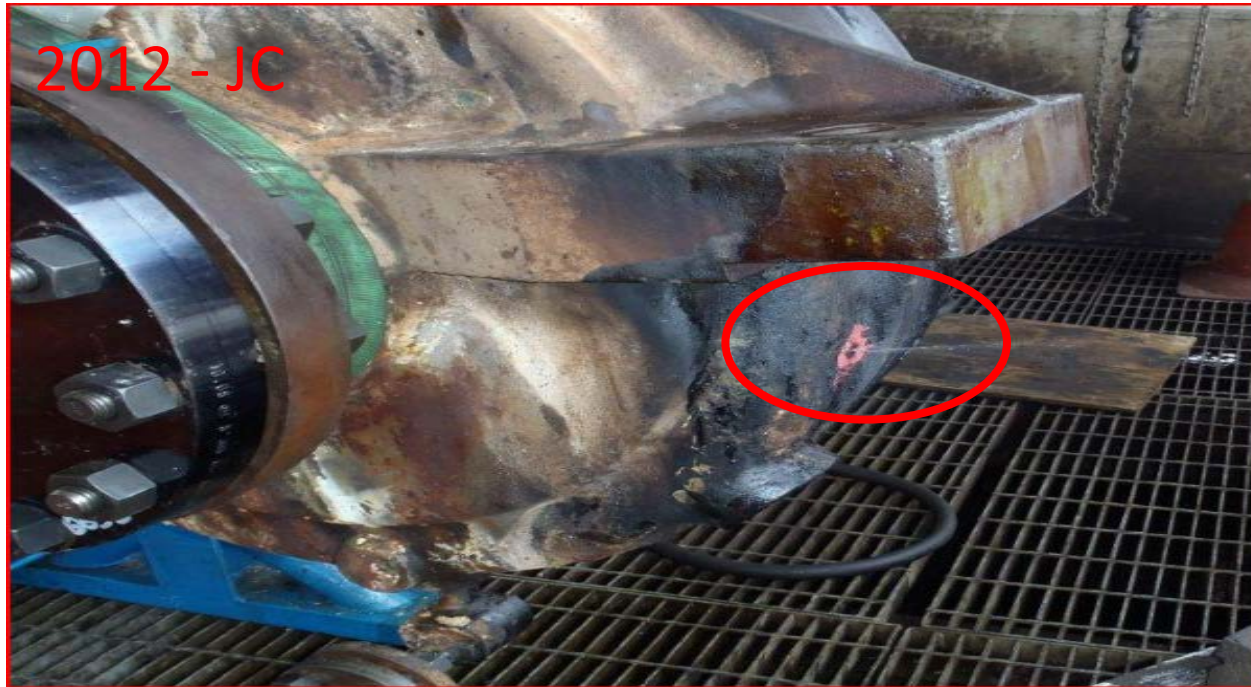
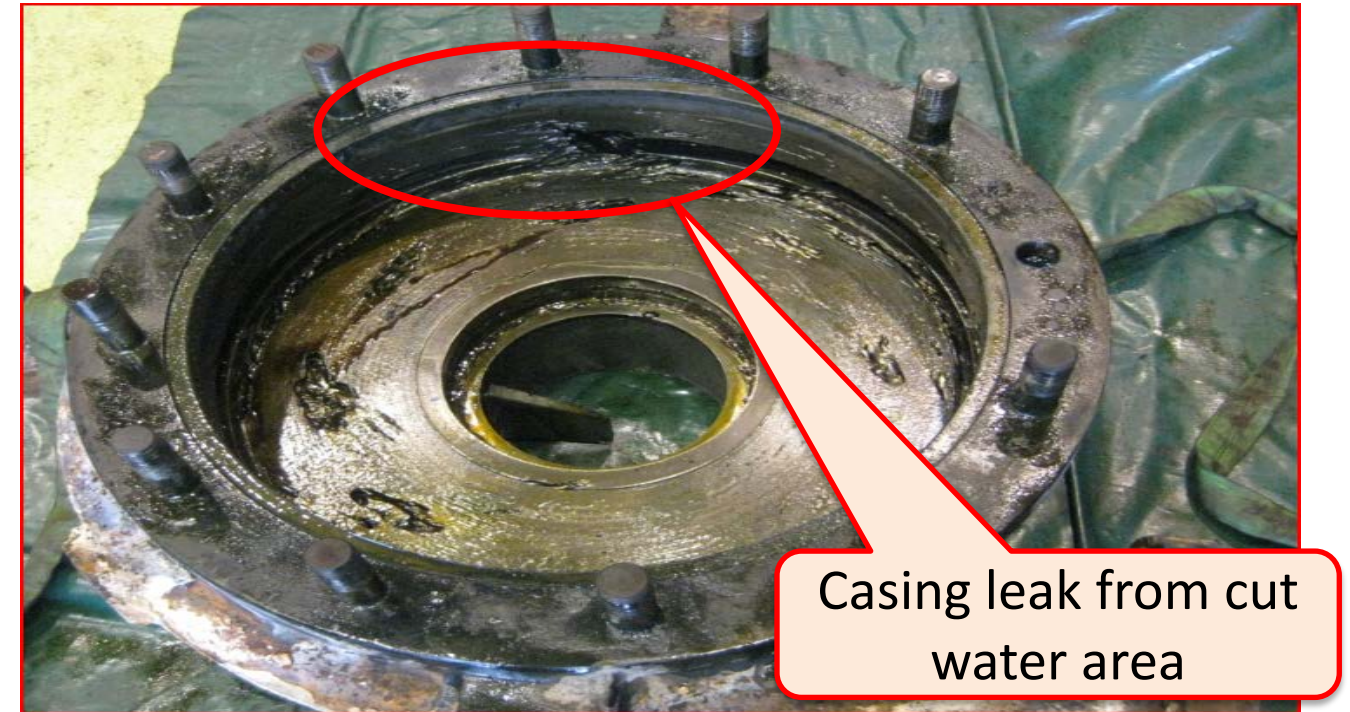
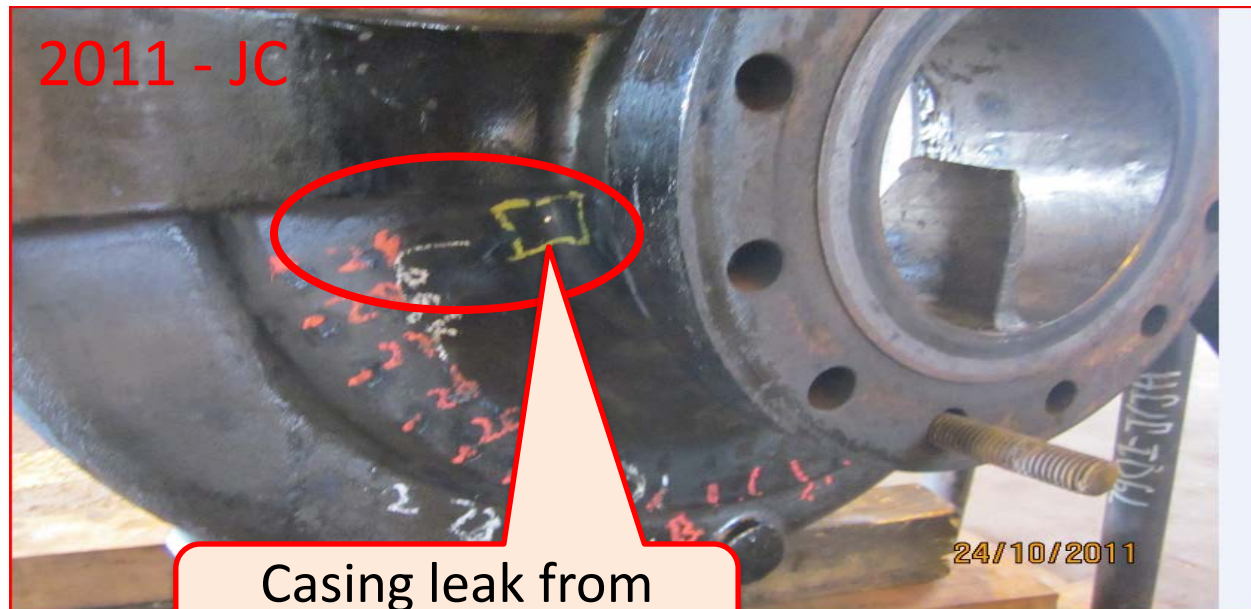
Casing leak from  
suction nozzle

Casing leak at:

1. Suction nozzle
2. Casing volute - cut water area

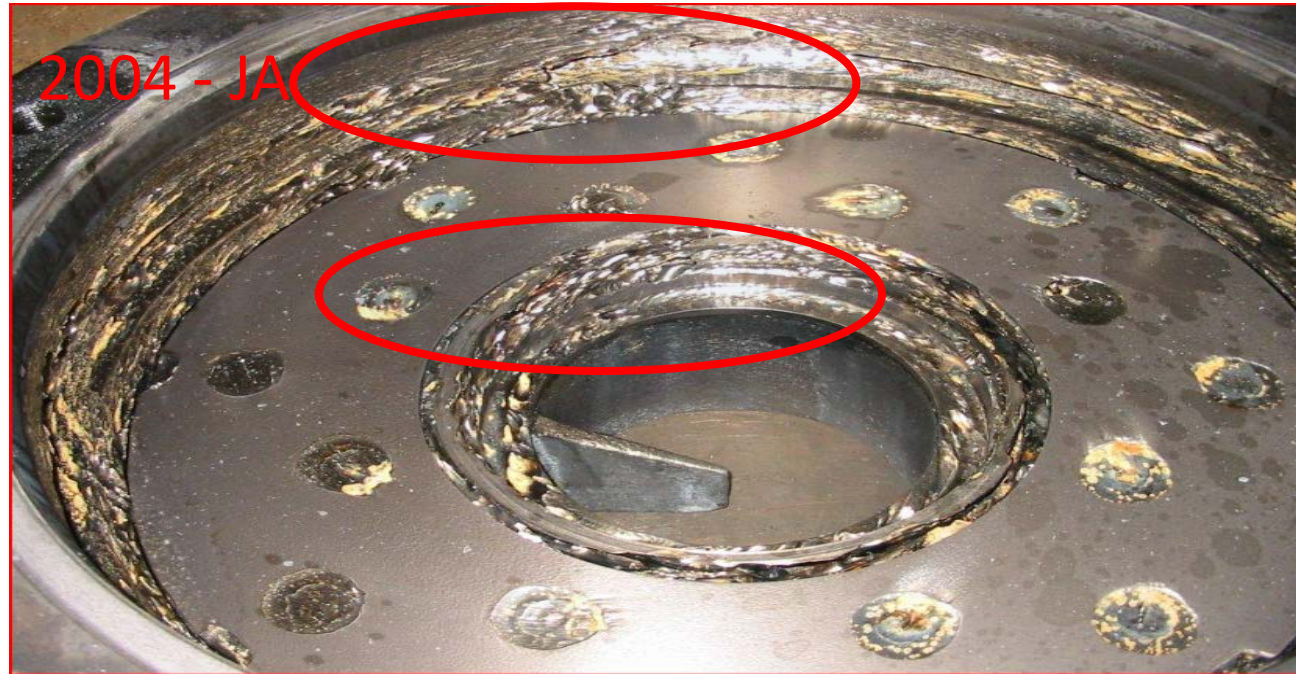
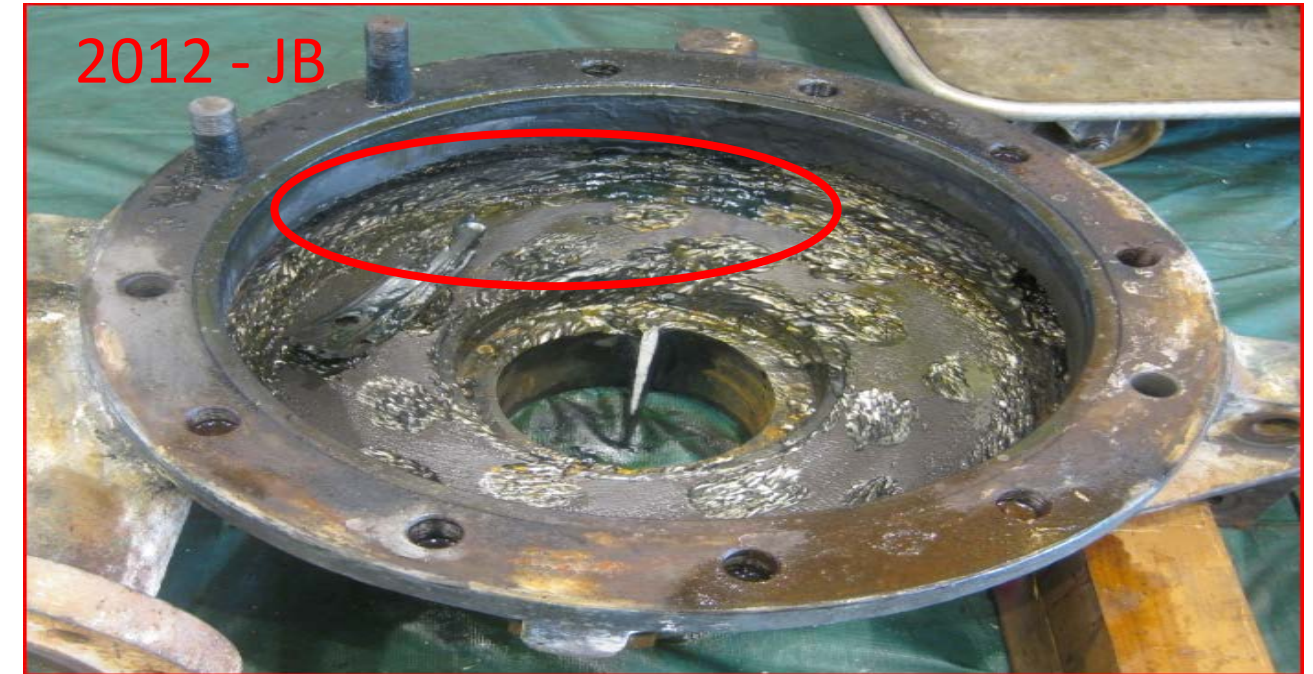
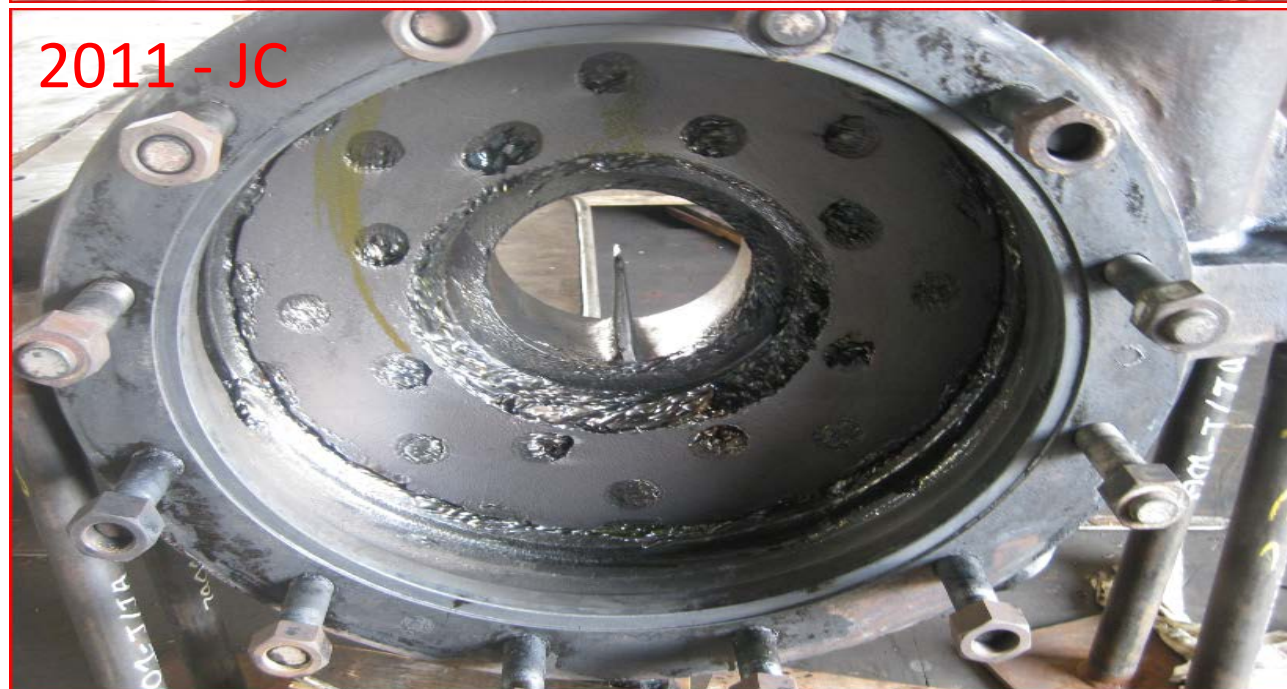
Erosion mainly occurs at:

1. Cut water area
2. Grub screw area – not hardened locations.
3. Suction wear ring area

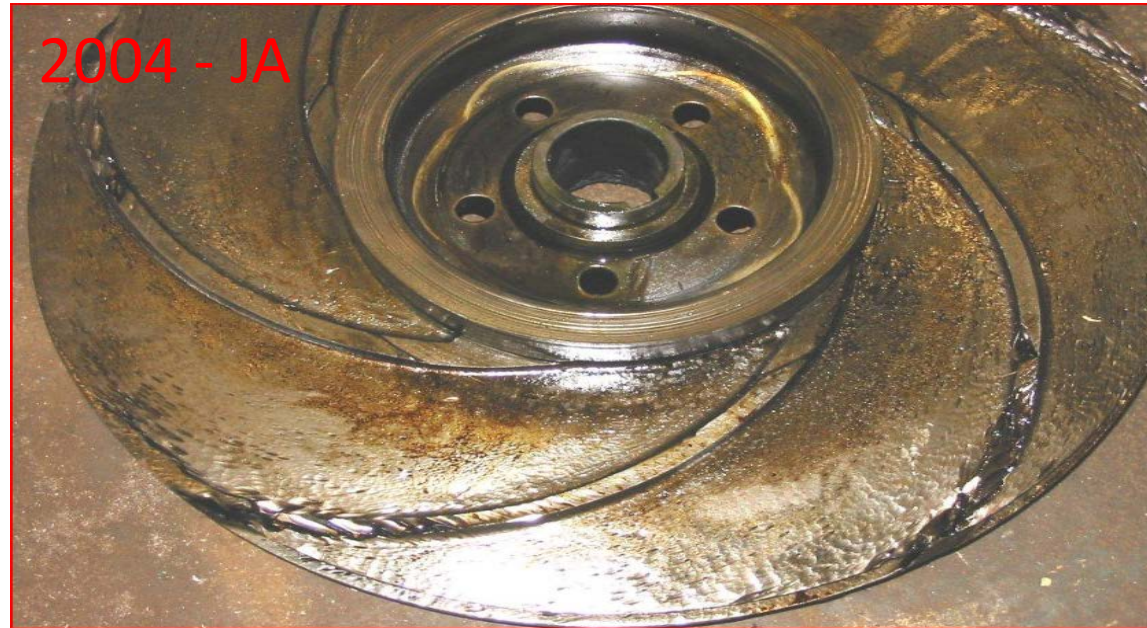
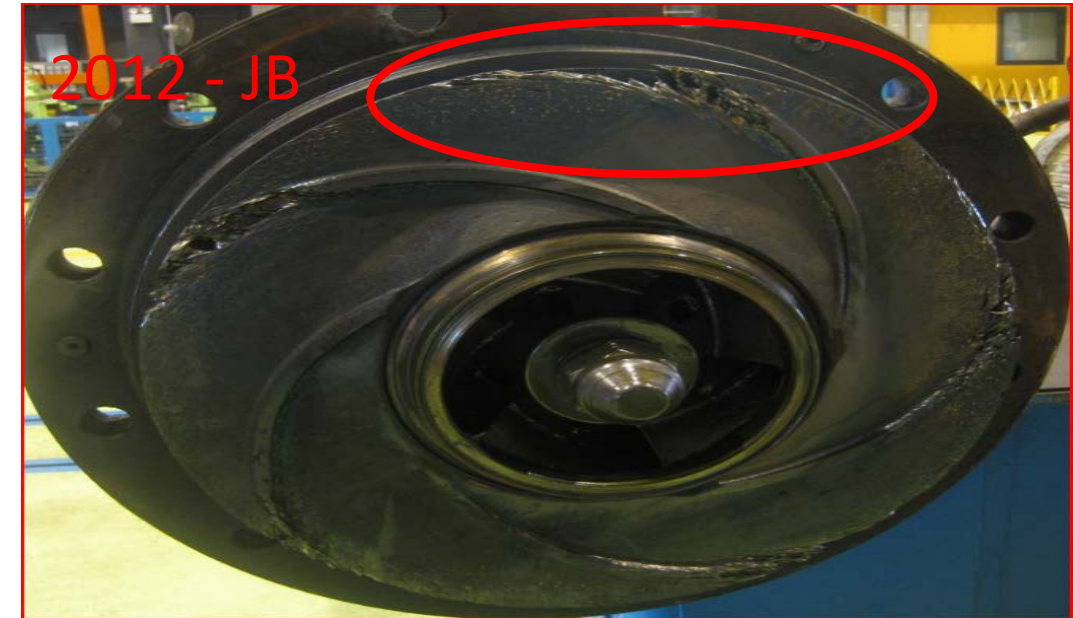
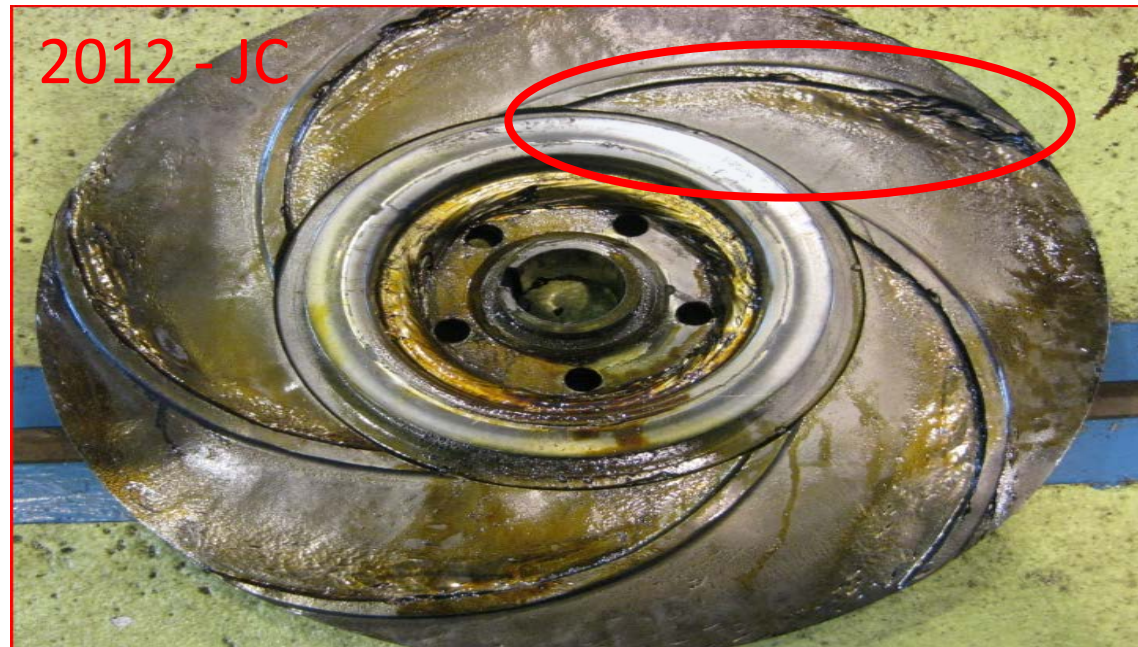
- Erosion starts at pump out vane edges and propagates to ends

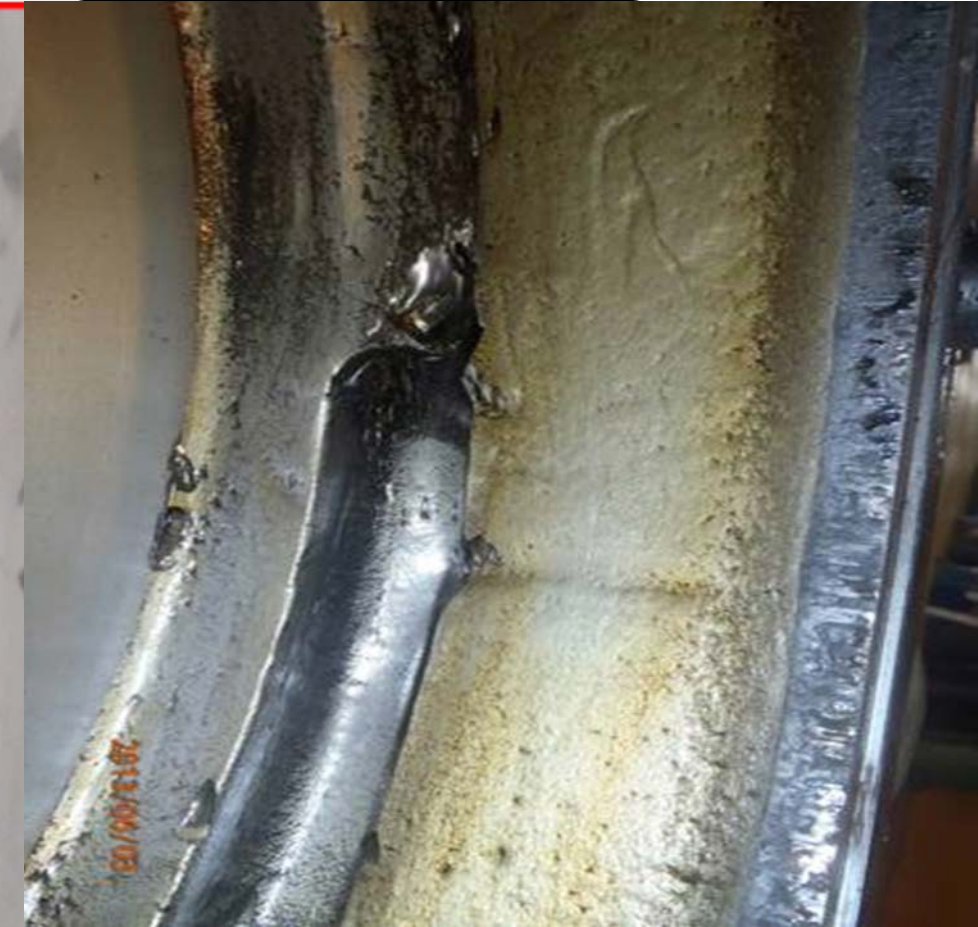
Present

Eroded cavity  
10mm deep x  
5mm width

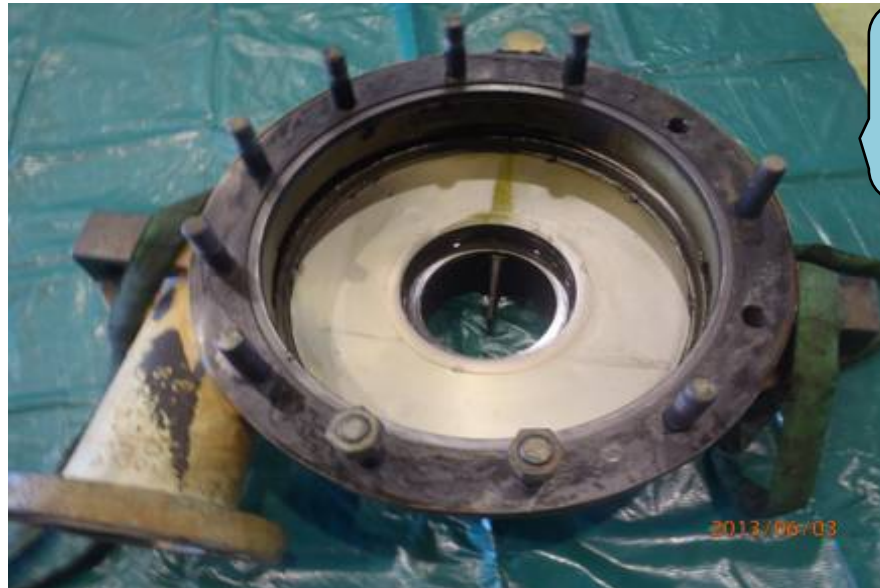
Present  
condition

- Shows erosion at cut-water exit area.
- Shows erosion pitting on volute area.

- Max size impeller to be stocked in warehouse. This would help to bring down the speed further.
- Tungsten carbide coating is effective so would remain the repair technique for present moment.
- To improve the cut-water erosion, a stellite insert will be used at the critical area.
- OEM has confirmed that the flushing oil to the suction wear ring could be stopped and the impeller back vanes could be removed without any effect to the pump bearings.

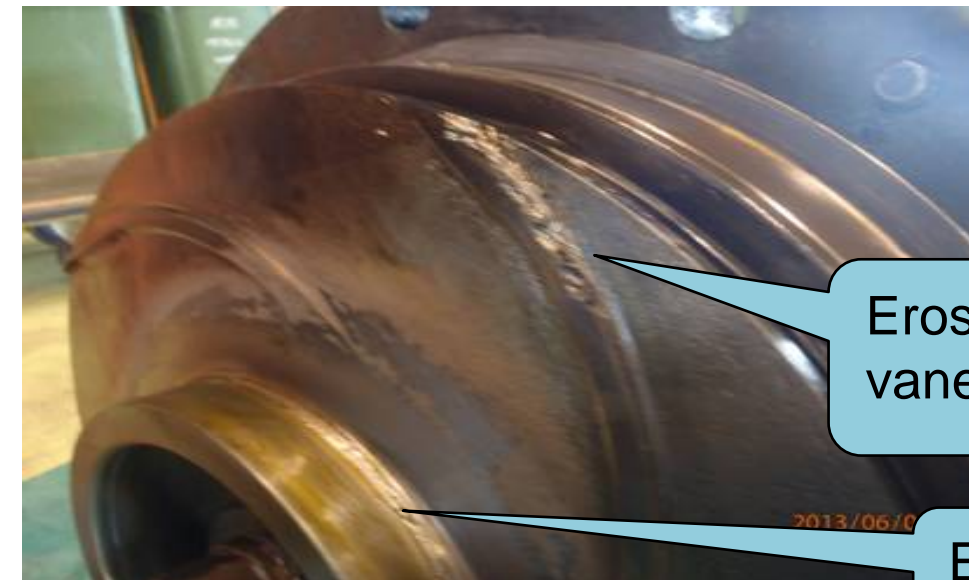
After 12  
Months

Erosion at Pump out  
vane leading edge

Erosion at Wear-ring  
neck

- Shows initial stages of erosion at pump out vanes and impeller wear ring neck area.

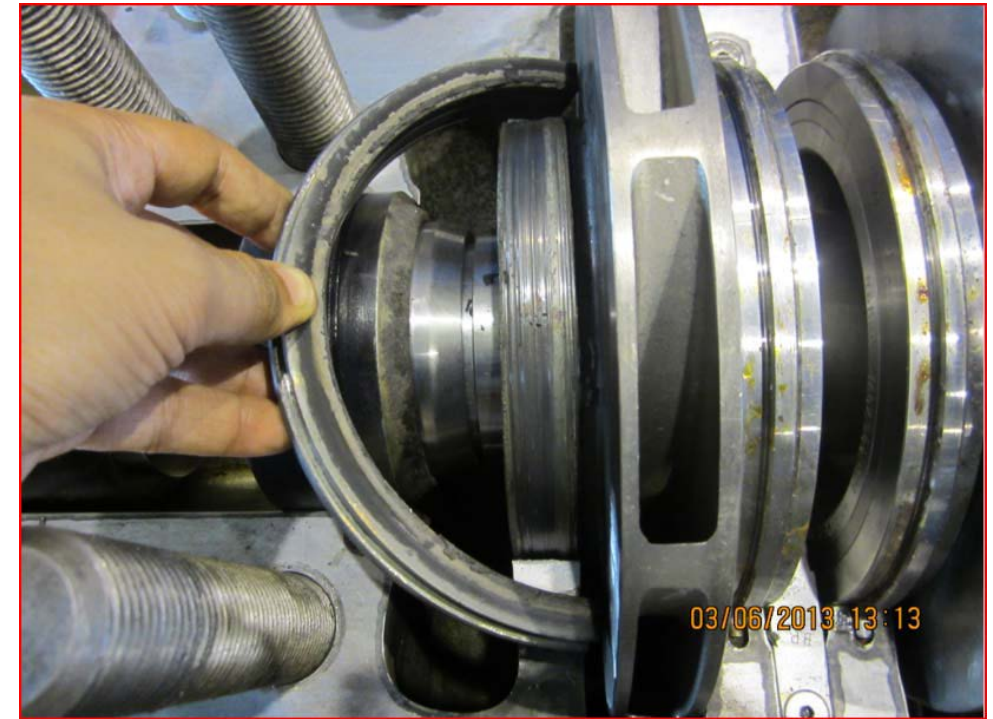
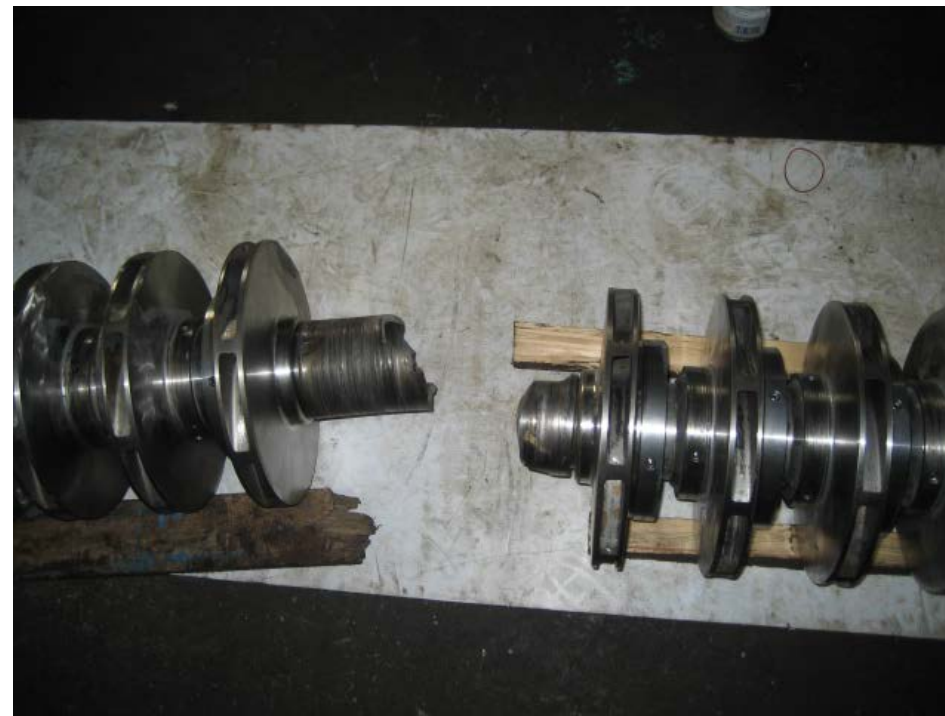
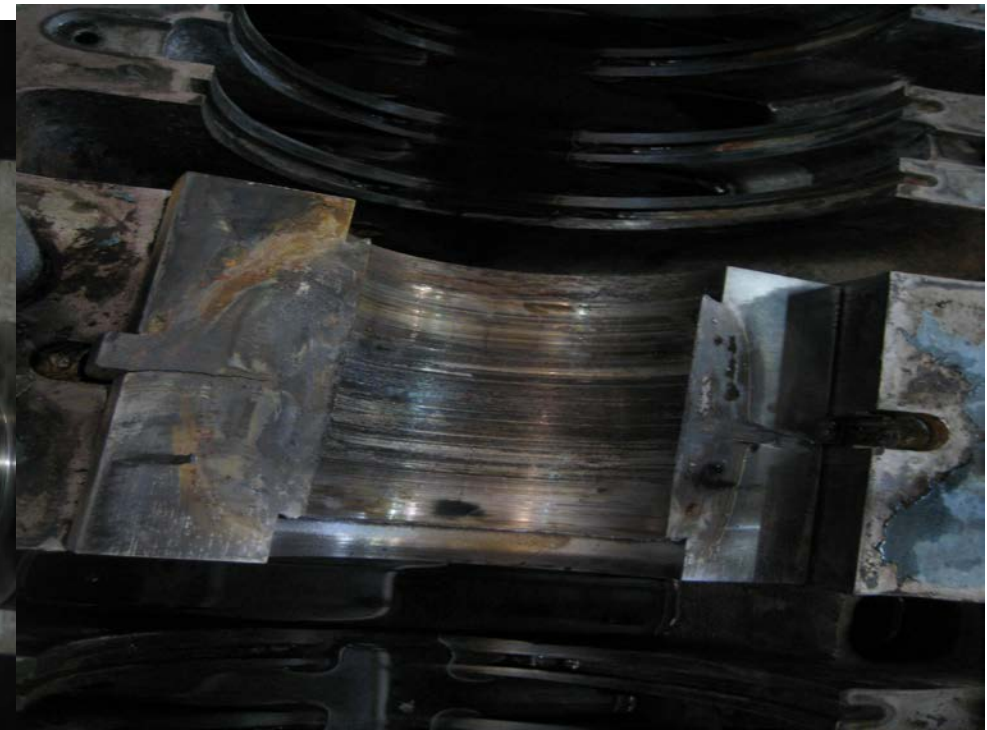
- Multiple seal failures
- Seizure of the rotor
- Rotor breakage
- High wear & tear to the casing internals

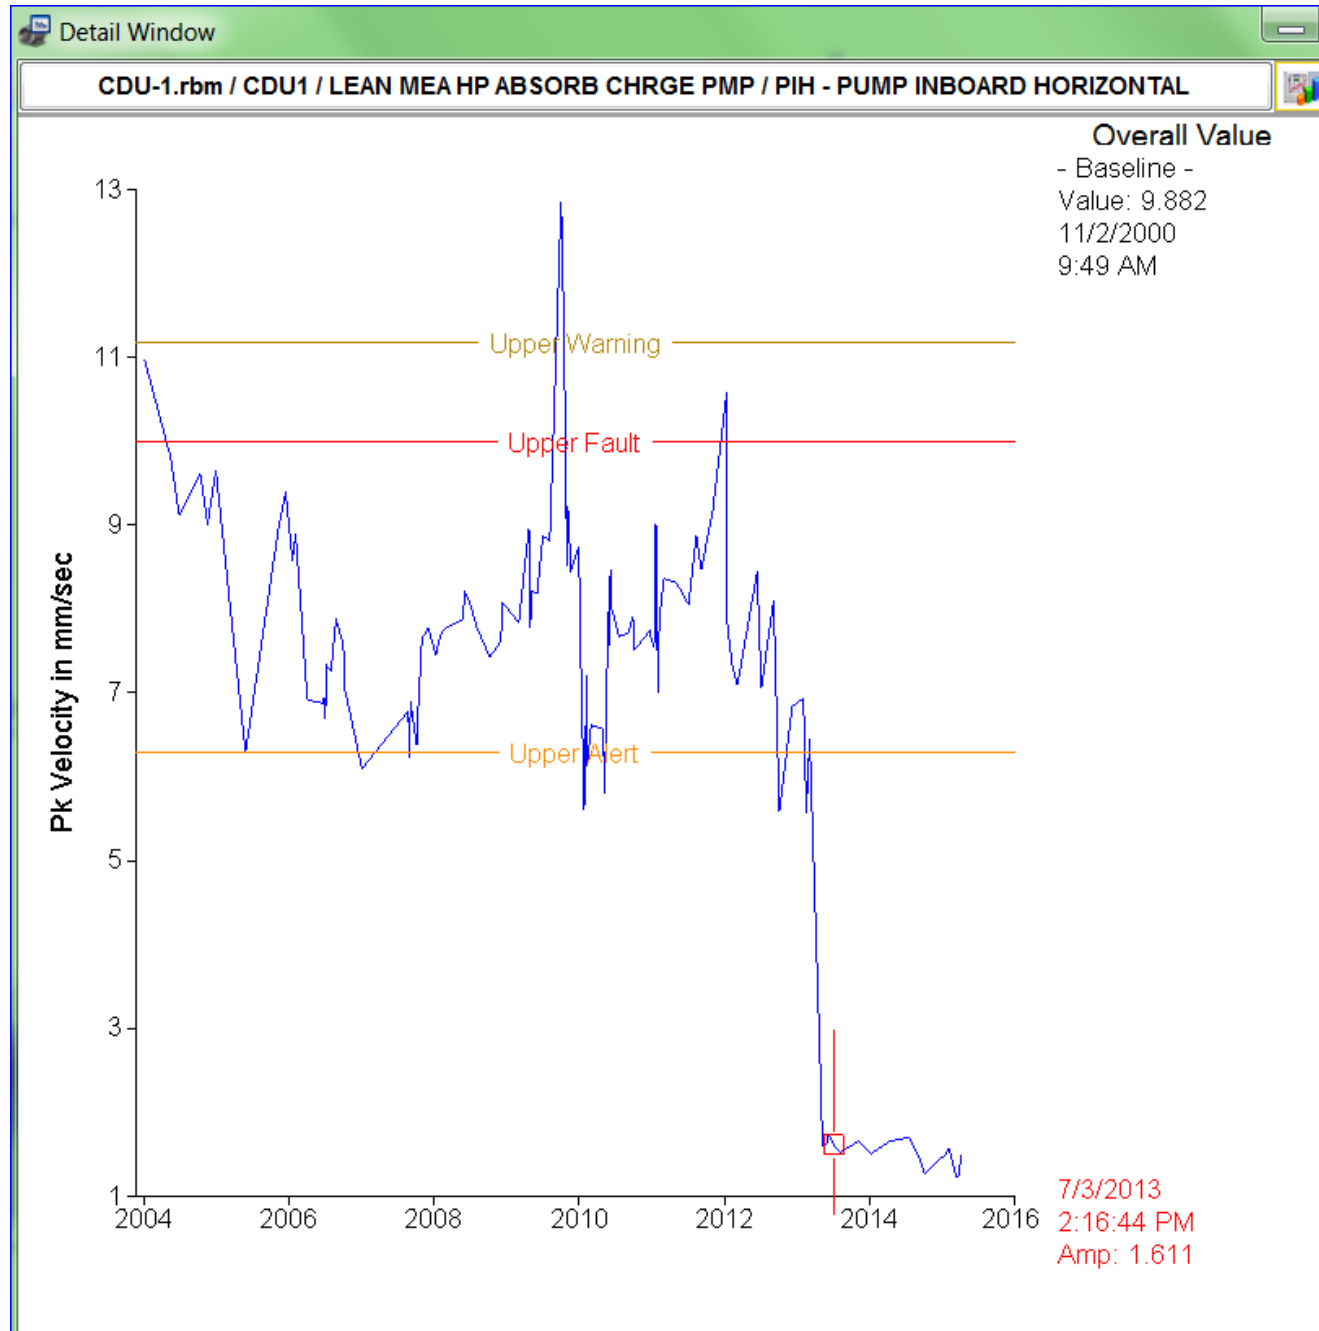
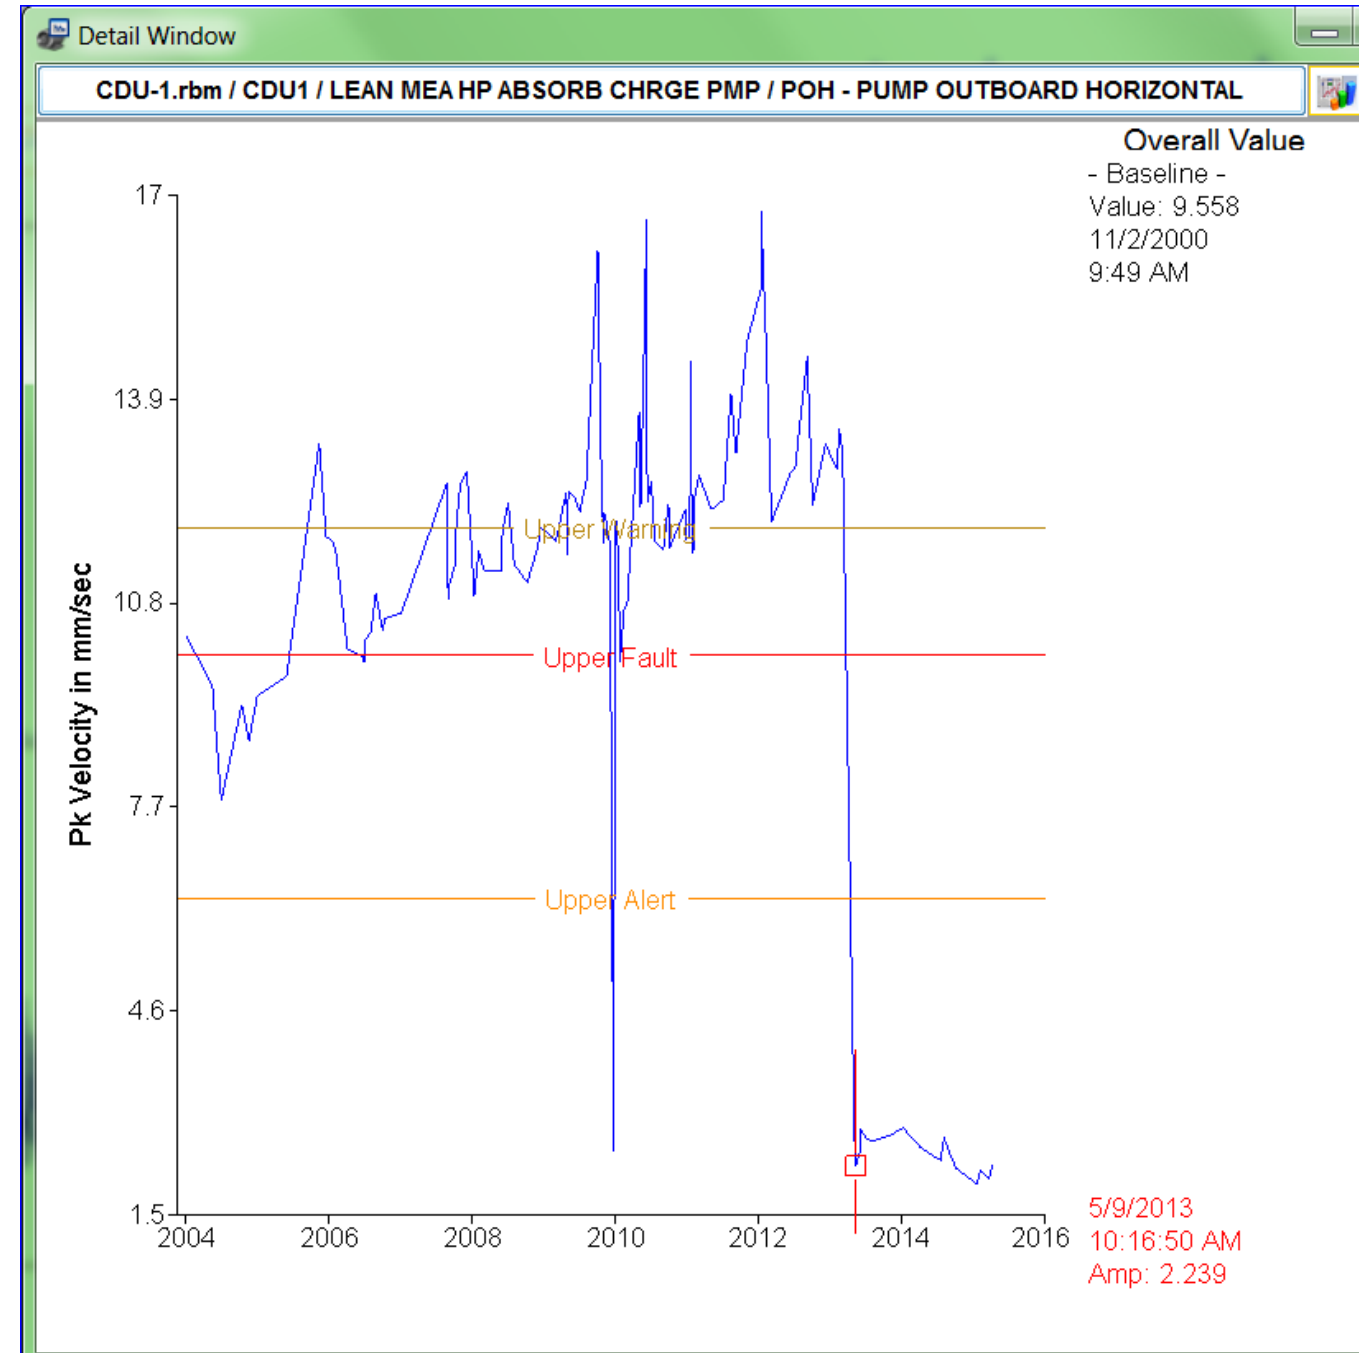
Significant reduction in pump bearing housing vibrations post overhaul  
No major failures in the pumps post 2013 for both the pumps.
